Tank Bottom Scanners

Magnetic Flux Leakage (MFL)

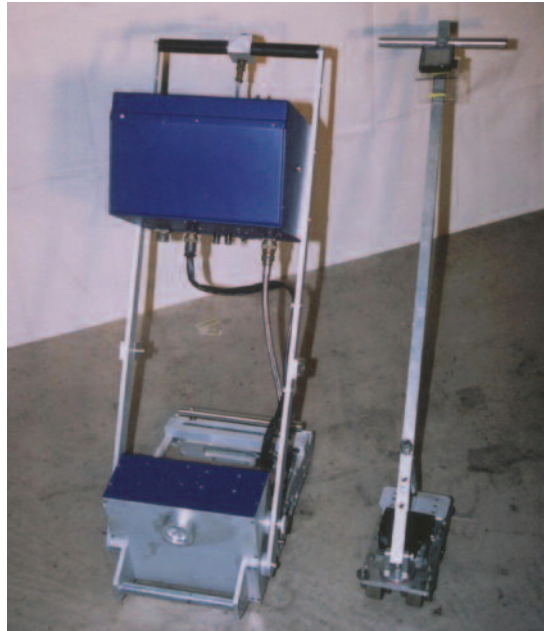
HMT’s bottom scanner is a steerable motorized corrosion detection instrument used in aboveground storage tanks to detect metal loss due to corrosion. MFL technology induces a magnetic field into the steel plates and then evaluates any disturbance in the magnetic field. When the magnetic field is disturbed, possible metal loss (either product side or soil side) has occurred and must be evaluated “proved-up”. The HMT bottom scanner features “stop on defect” functionality. When metal loss is detected the machine automatically stops, thus reducing human error resulting from missing a screen signal.
